# Manhole Inspection Summary

Manhole # S51A\_\_012MH

Insp Date: **5/6/08 11:07 AM**

**Location** Address: **rear 411 n linwood ave**

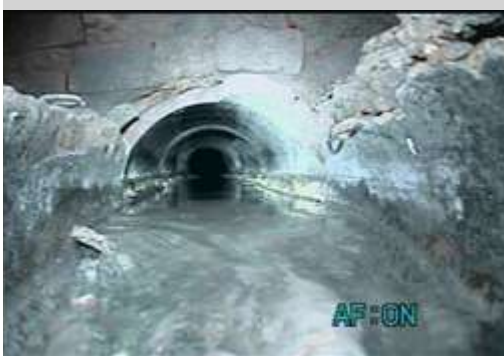
Defect 3

Condition: ☐ Sound ☒ **Cracked** ☐ Root Intrusion ☐ Deteriorated ☐ Leaks ☐ Debris

Bench Condition Cracked

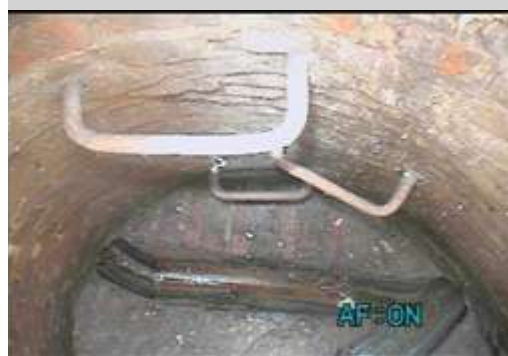
Defect 2

**Steps** Count: **3** Missing: **0** ☒ **Corroded**

steps

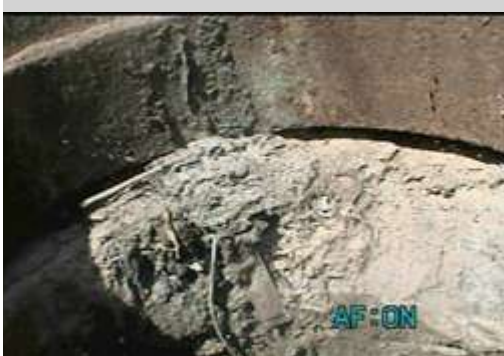
Defect 1

**Frame** Offset: **2** (in.) Condition: ☒ Sound ☐ Cracked ☐ Leaks

Condition: ☐ Sound ☐ Cracked ☐ Root Intrusion ☐ Loose Brick ☒ **Deteriorated**

FRAME\_OFFSET and Chimney  
Deteriodated

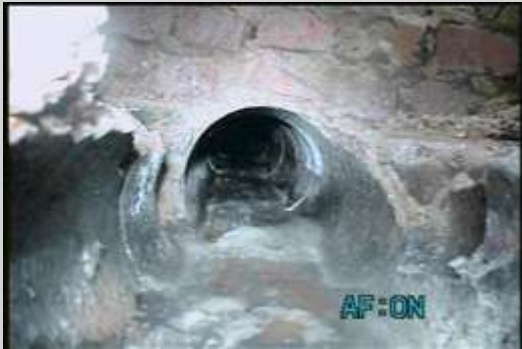
12 O'Clock Outflow

8 in. Circular Gravity Sewer  
Pipe Out @ 12 O'Clock

Deposits: ☐ None ☐ Mud ☐ Sludge ☒ **Debris** ☐ Grease

Silt Depth: 2 (in.) Deposits Extent: **Medium**

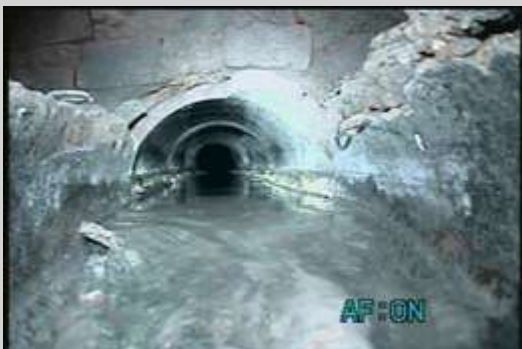
6 O'Clock Inflow

8 in. Circular Gravity Sewer  
Pipe In @ 6 O'Clock

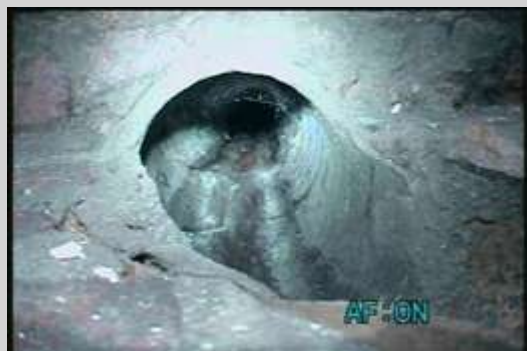
9 O'Clock Inflow

6 in. Circular Gravity Sewer  
Pipe In @ 9 O'Clock

Deposits: ☐ None ☐ Mud ☐ Sludge ☒ **Debris** ☐ Grease

Silt Depth: **2** (in.) Deposits Extent: **Medium**

Connects To: **Dead End**
